**CAPT-BTL®**

*Shijiazhuang CAPT Full Standard  
Range of Steel TB Taper  
Bushings – A **New** Choice  
for Industrial Safety!*

**SHIJIAZHUANG CAPT POWER TRANSMISSION CO., LTD.**

**C45 Steel High-Strength TB Taper Bushings – Your Safe Choice!**

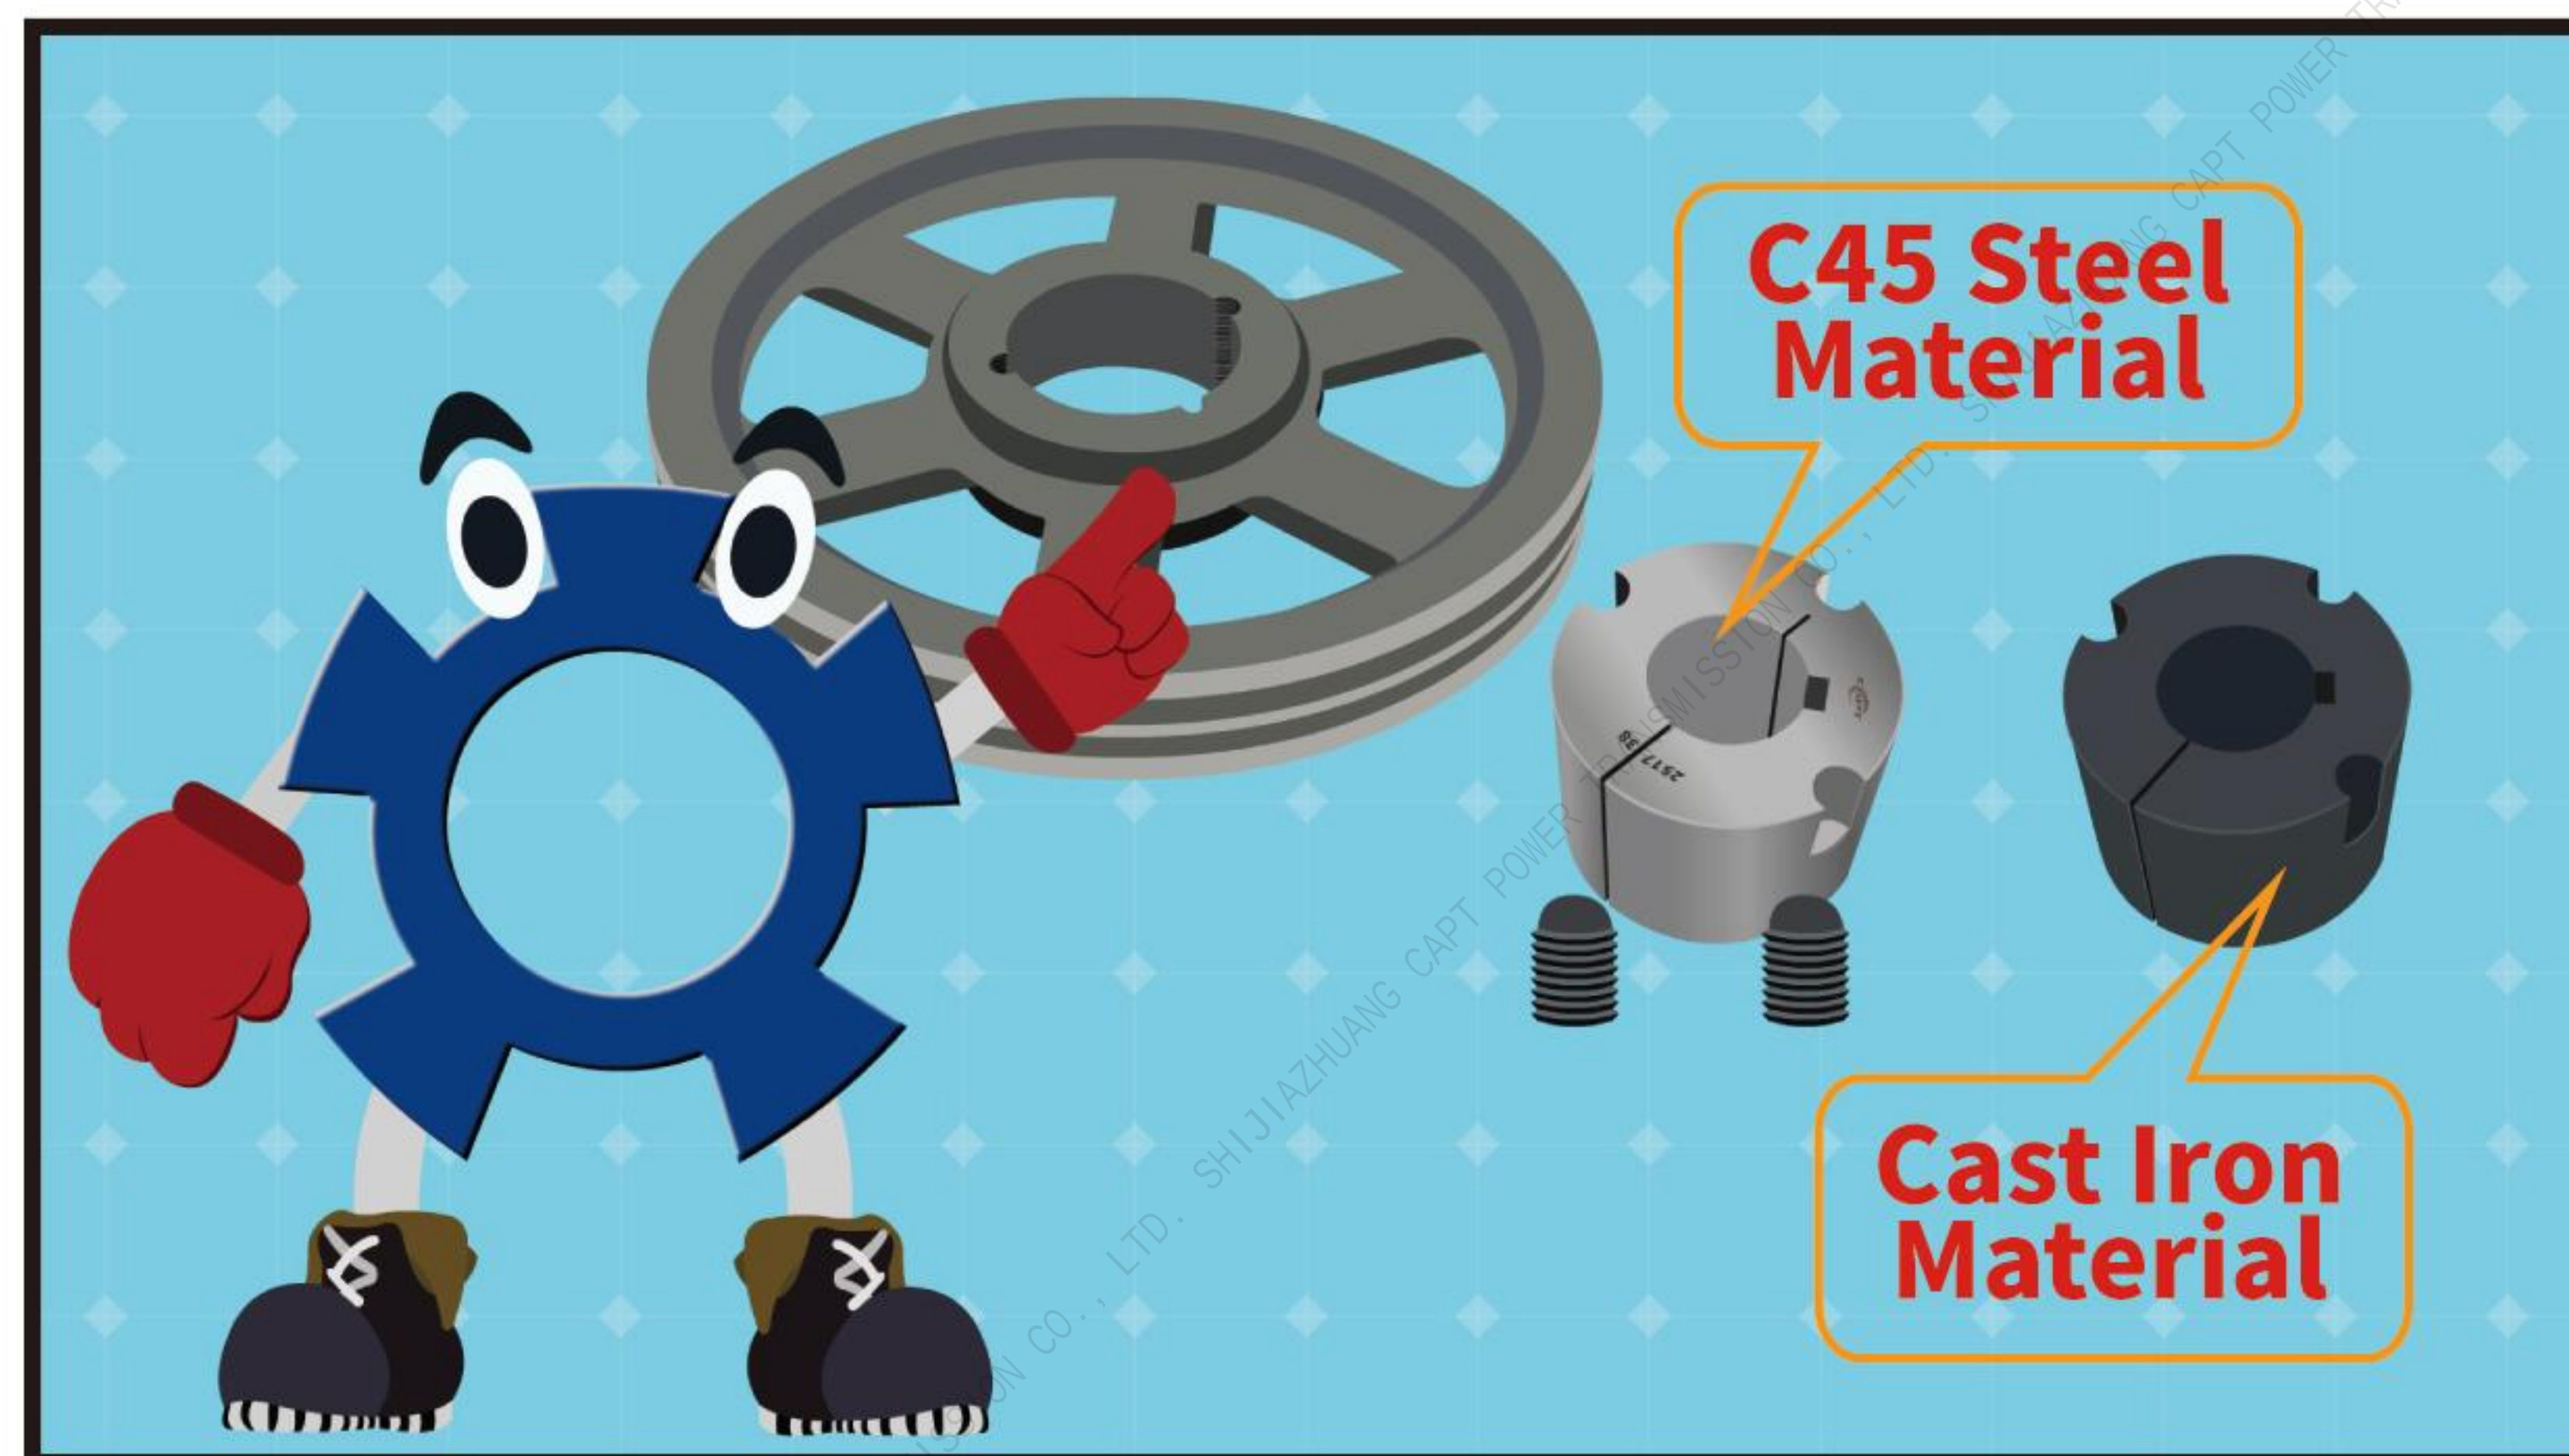
①TB taper bushings come in two types: high-strength and low-strength materials.

**C45 Steel Material**

**HT200 Material**

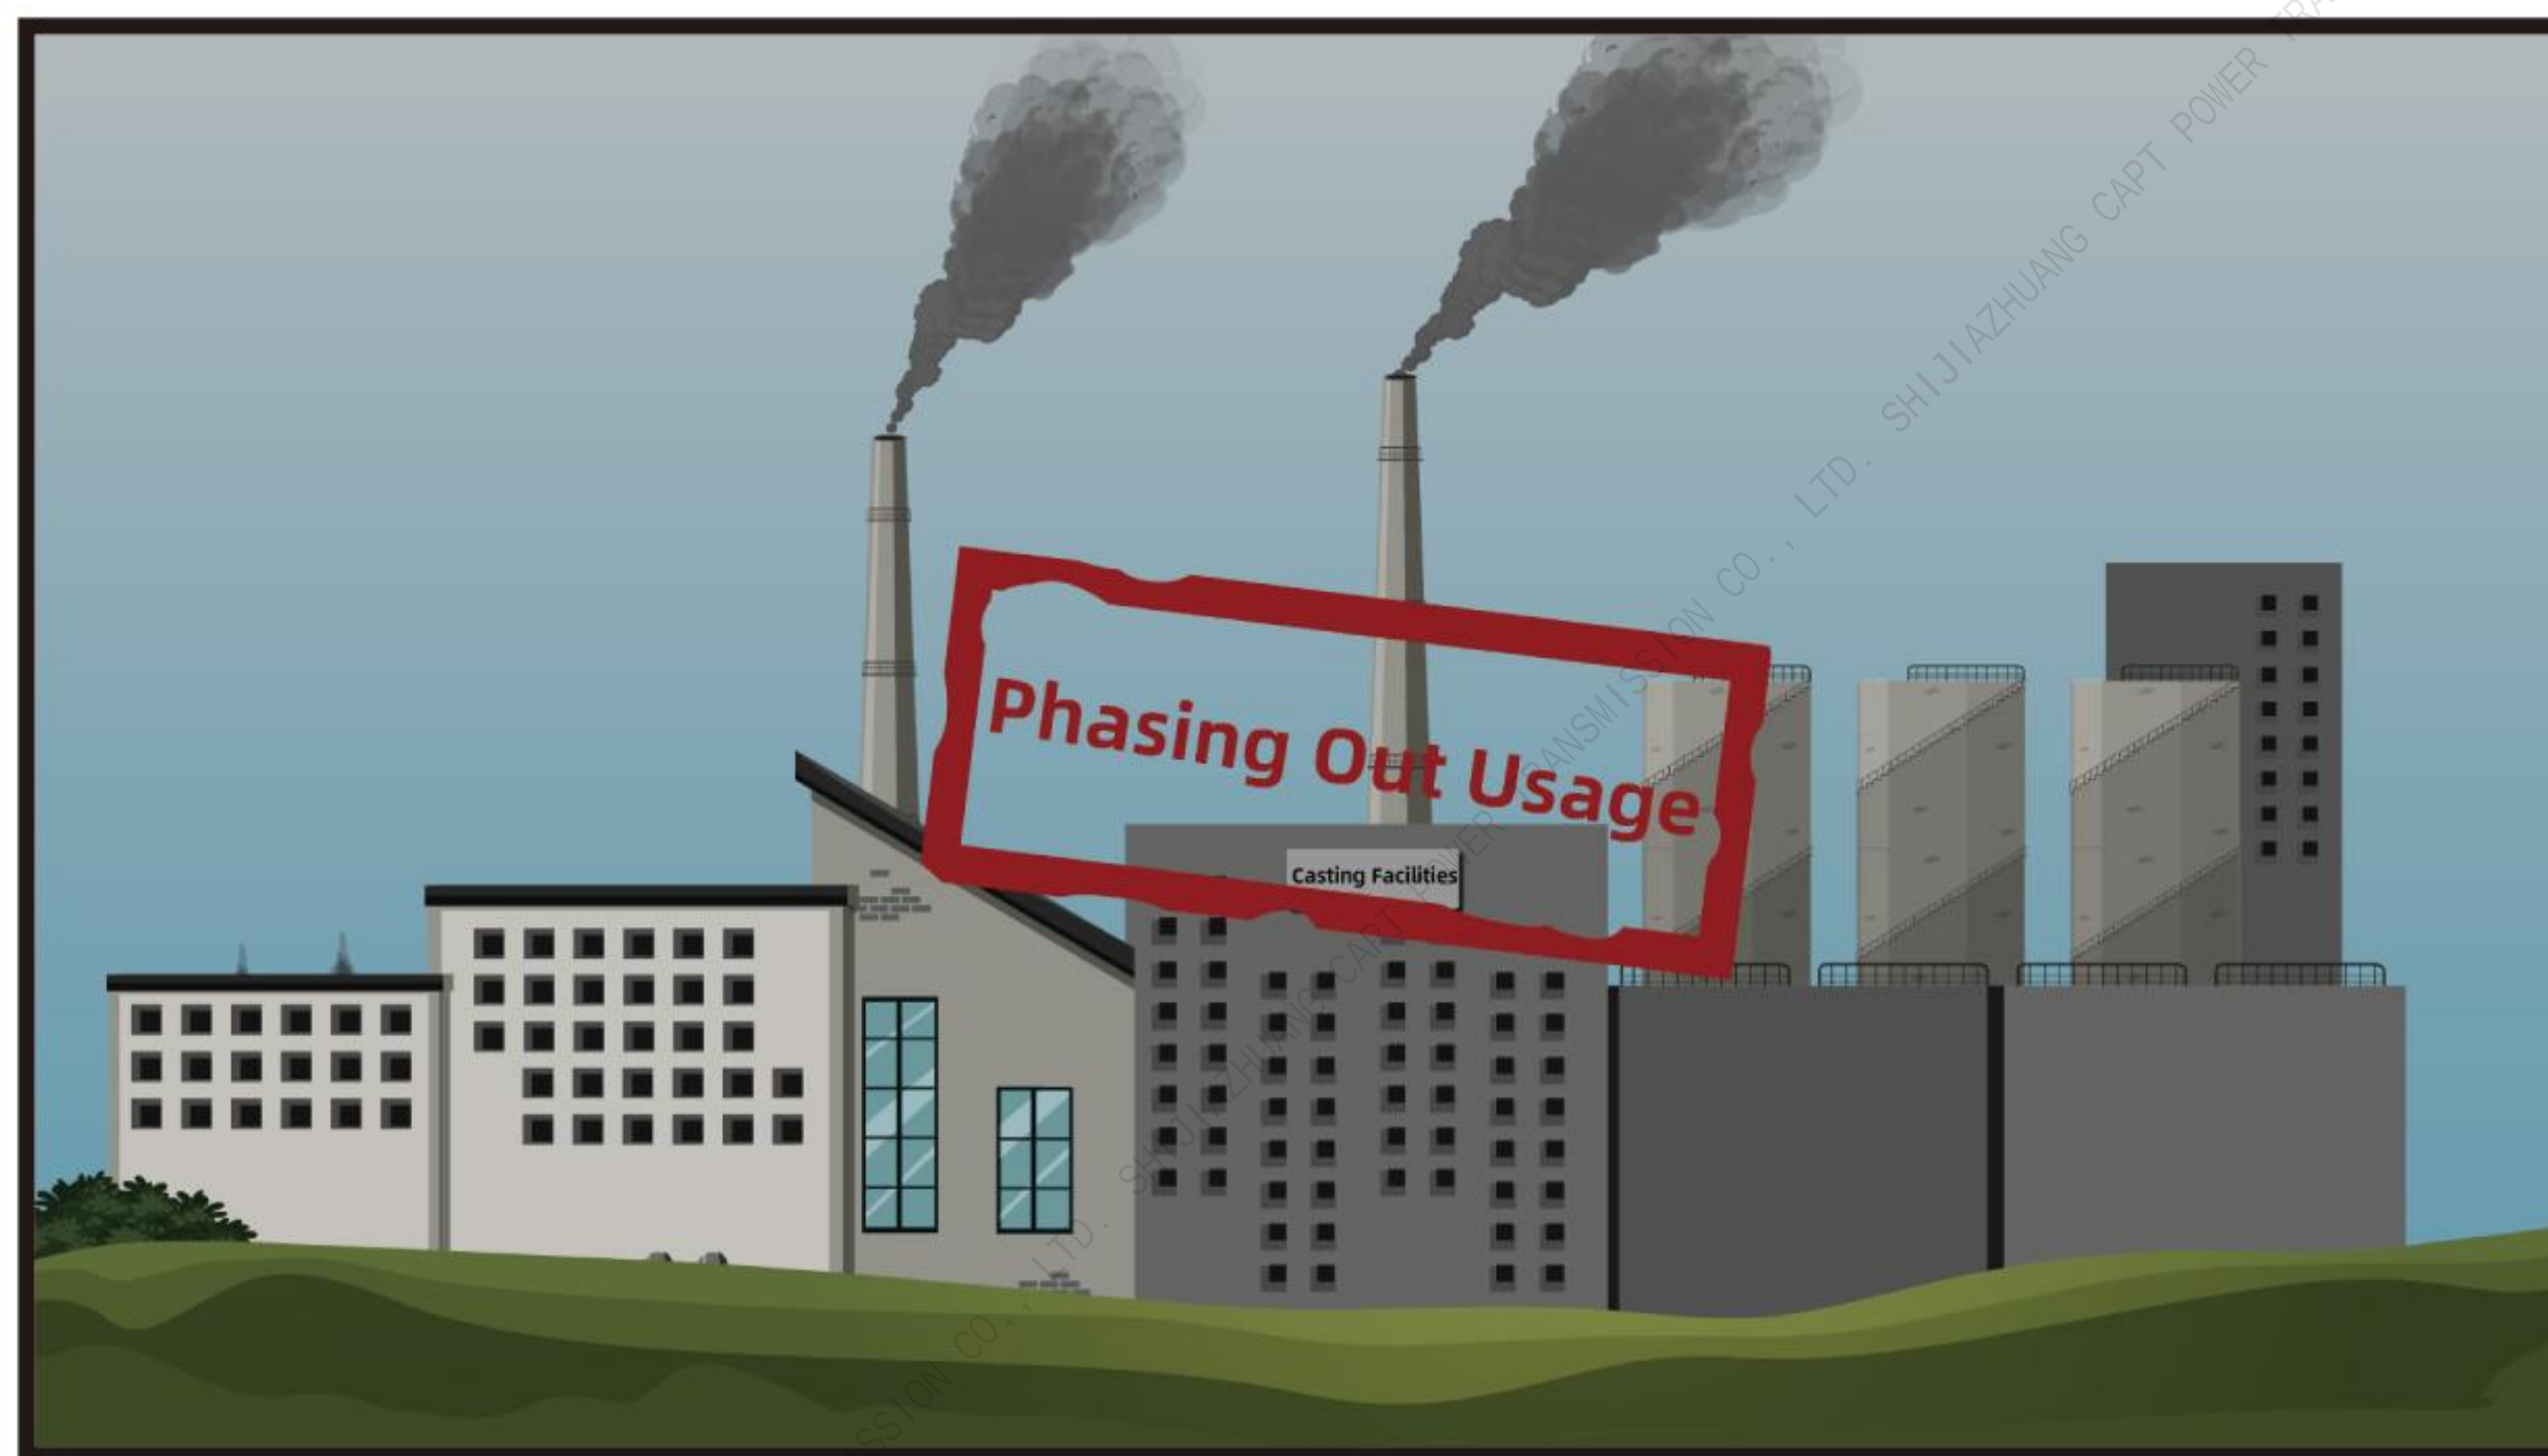
⑤ Eliminating cast molding improves safety, saves energy, and is environmentally friendly.

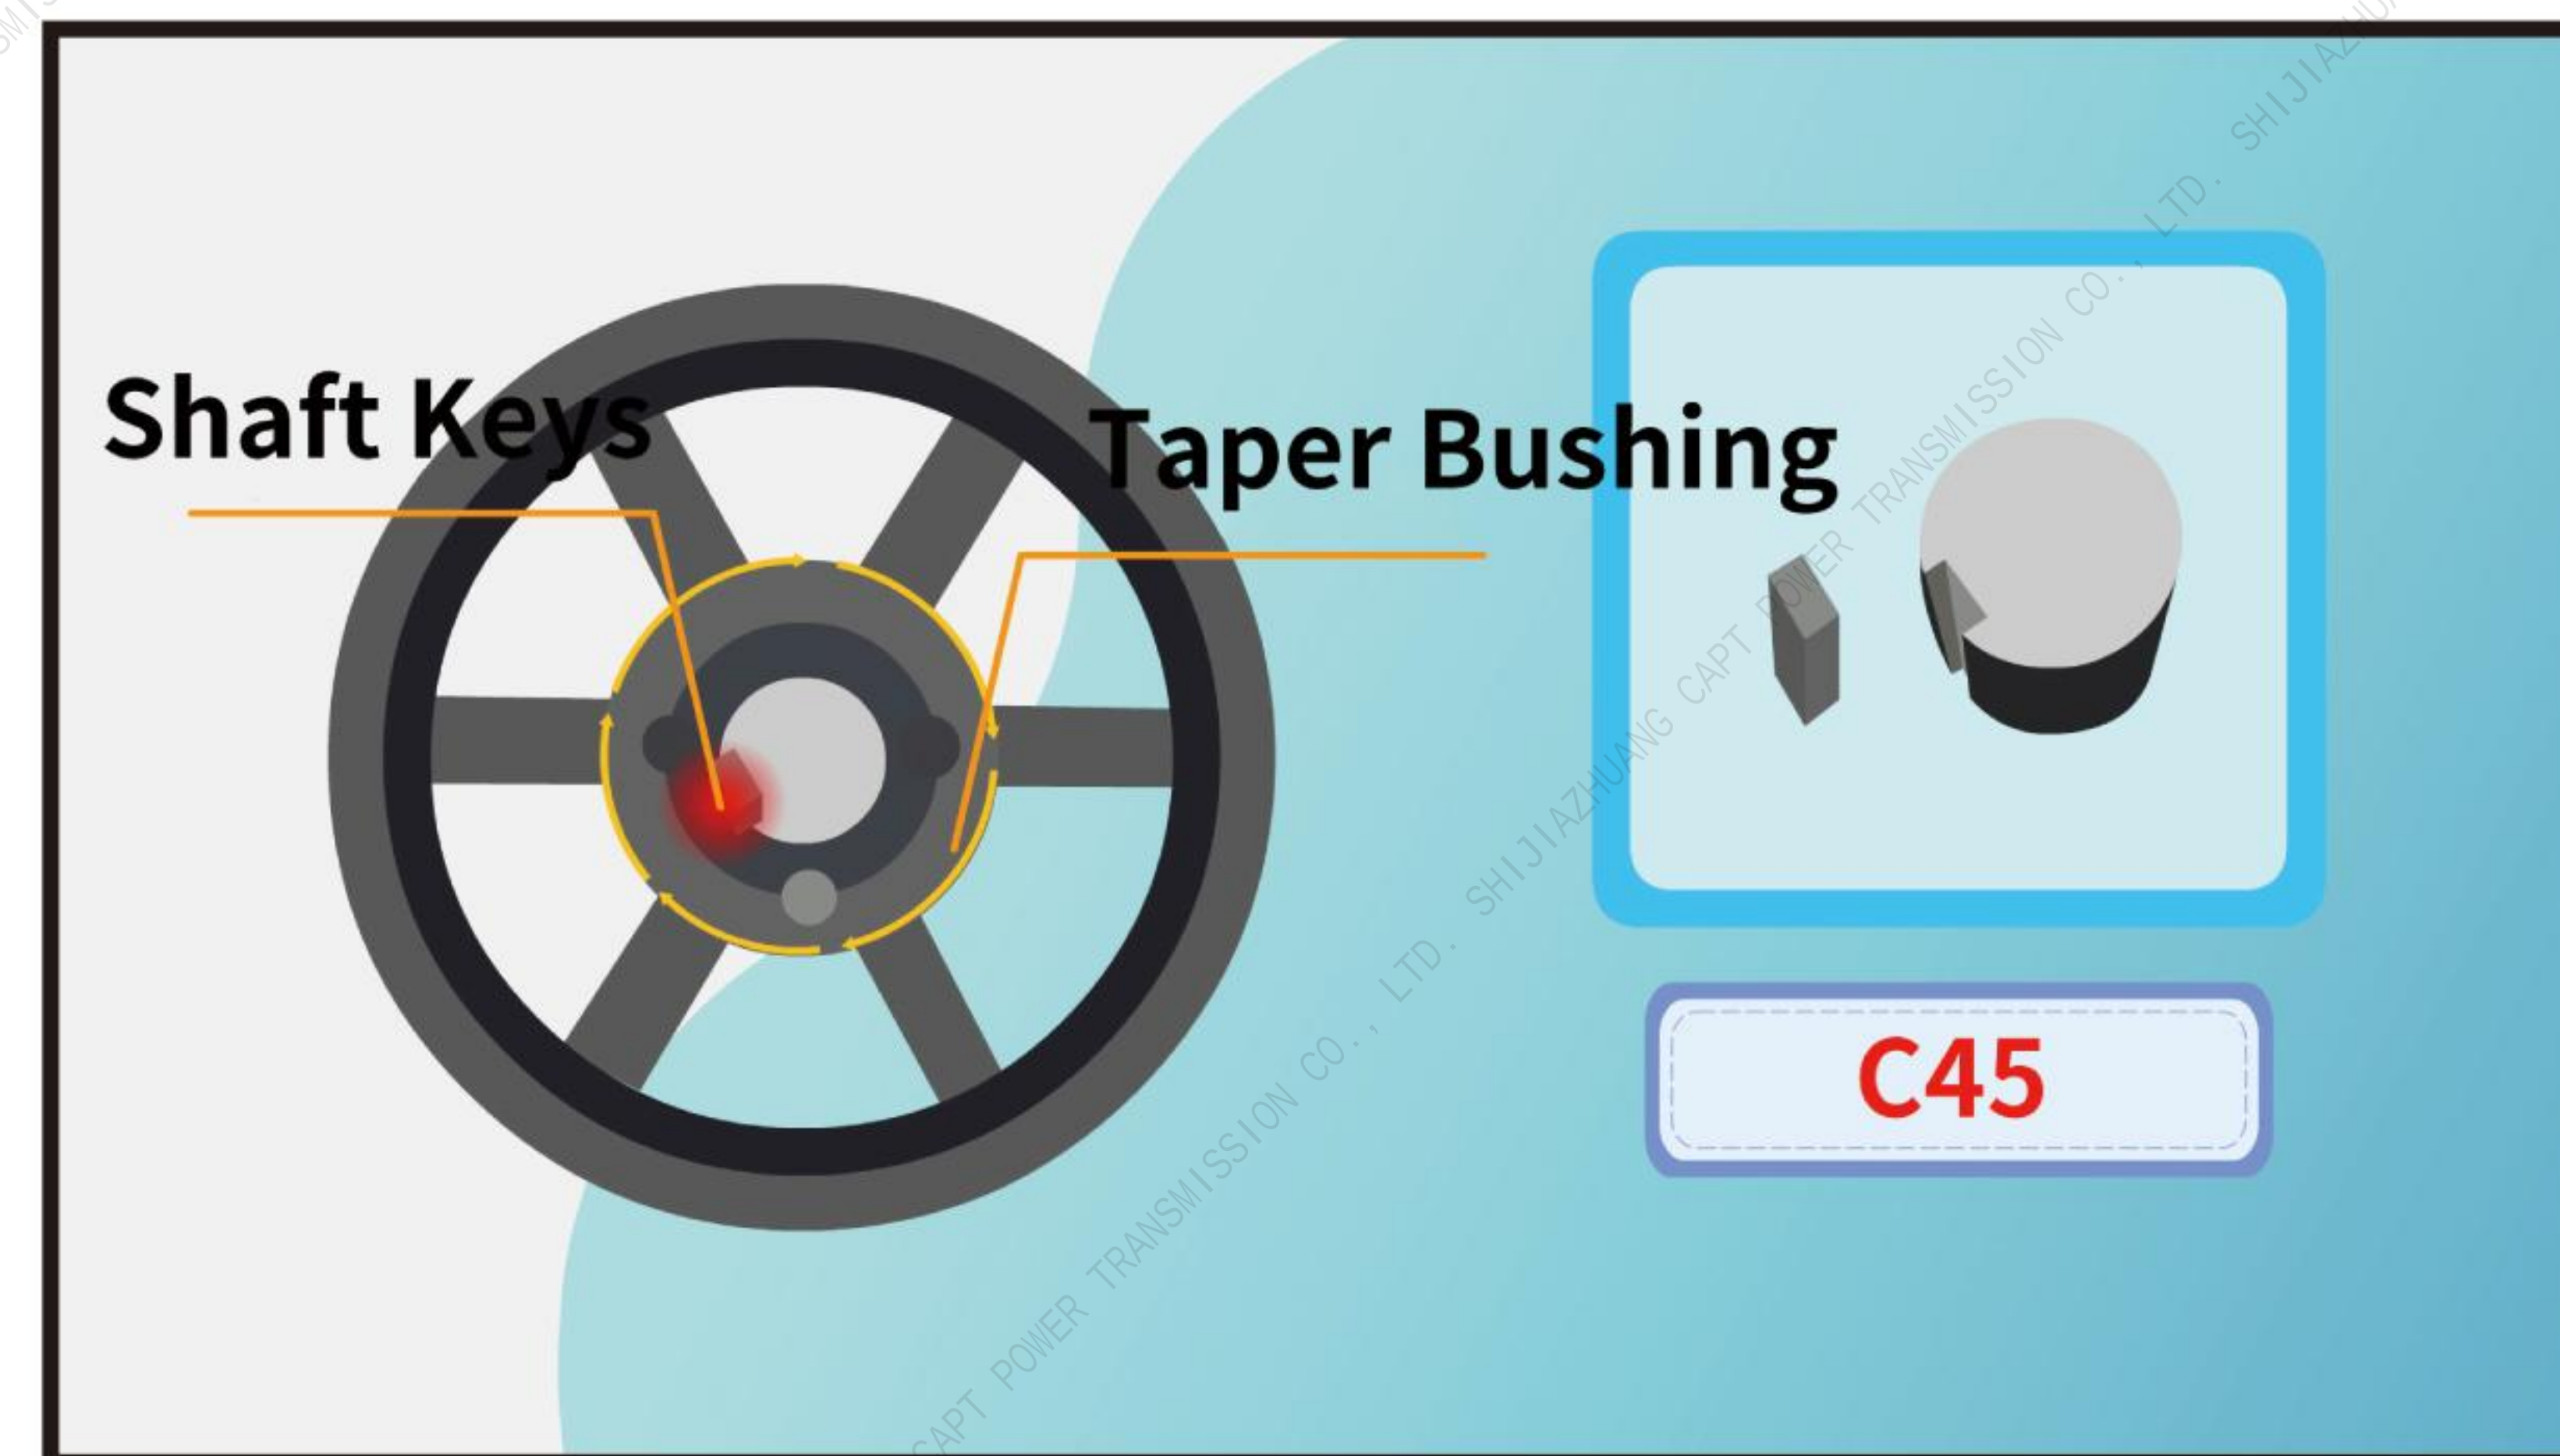
⑧ The tensile strength of C45 steel shaft keys is higher than that of cast iron bushings.

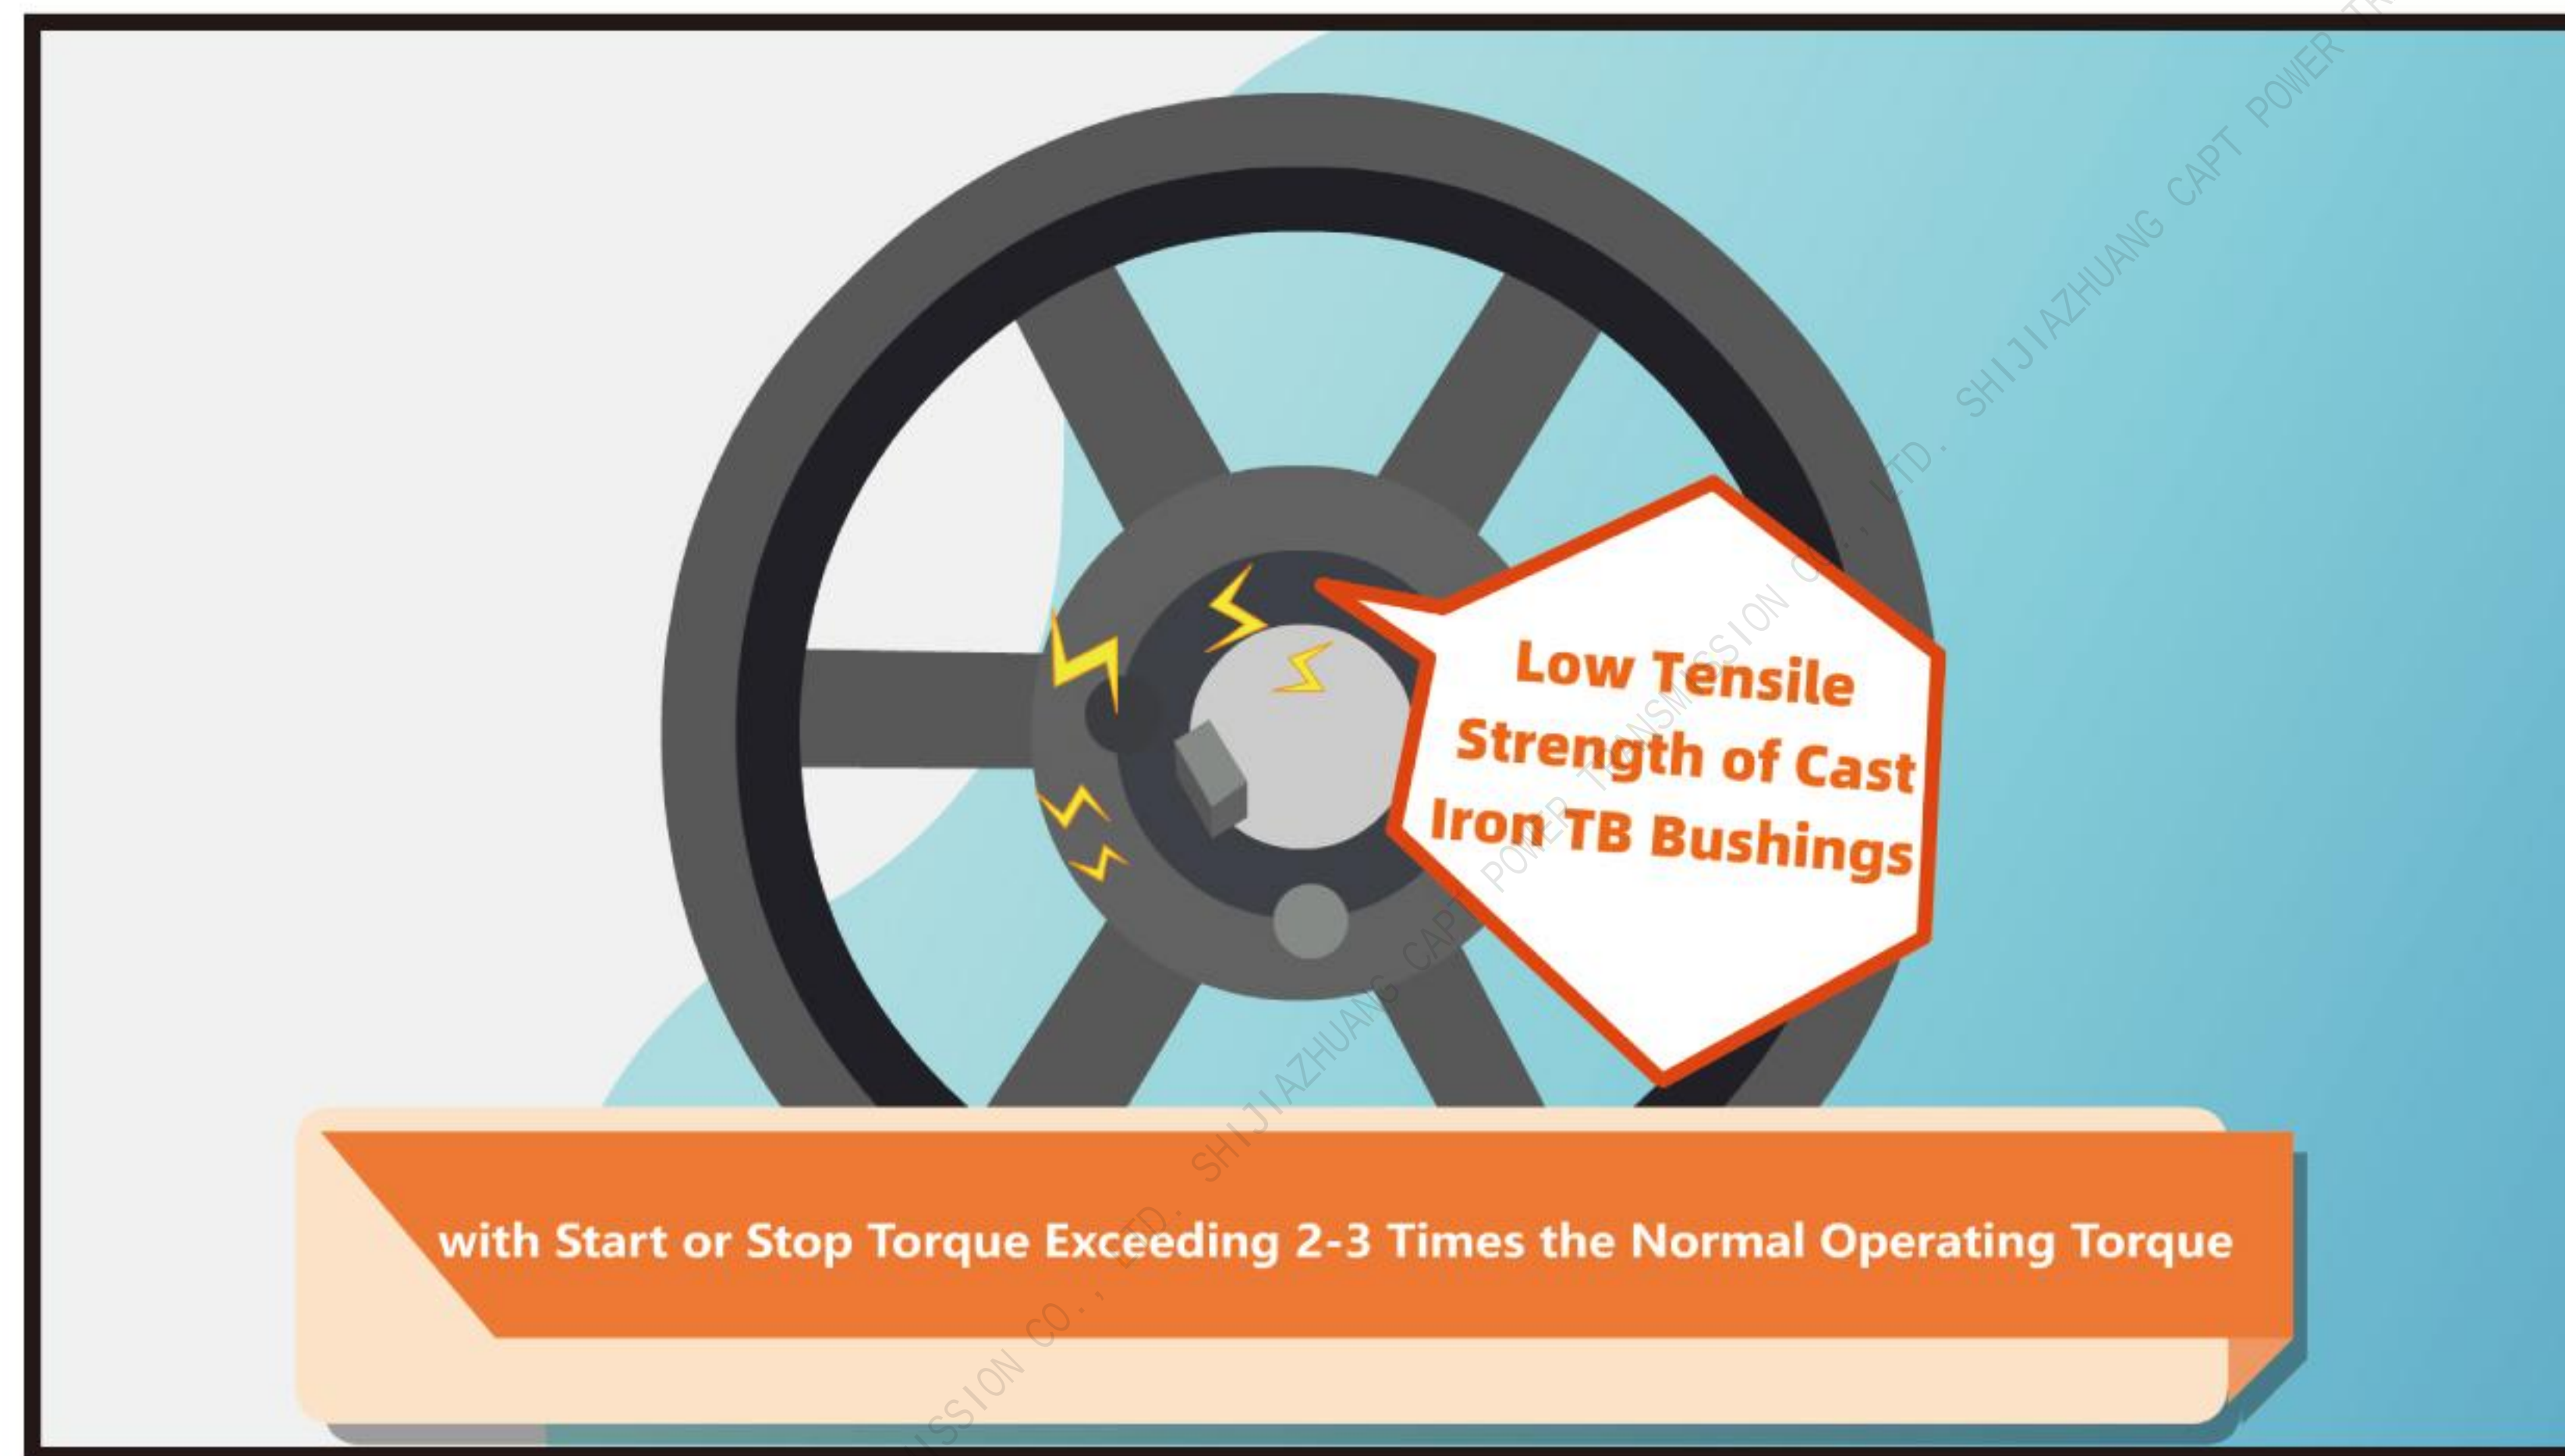
⑨During operation, strong torque impacts the weak keyway positions.
